AERIAL PHOTOGRAPHIC ANALYSIS OF THE ROCKFORD PRODUCTS CORPORATION, PLANT #3 Rockford, Illinois

TS-AMD-86615-5
June 1987

R. W. Helmstadt
Environmental Programs
Lockheed Engineering and Management Services Company, Inc.
Las Vegas, Nevada 89193-3478

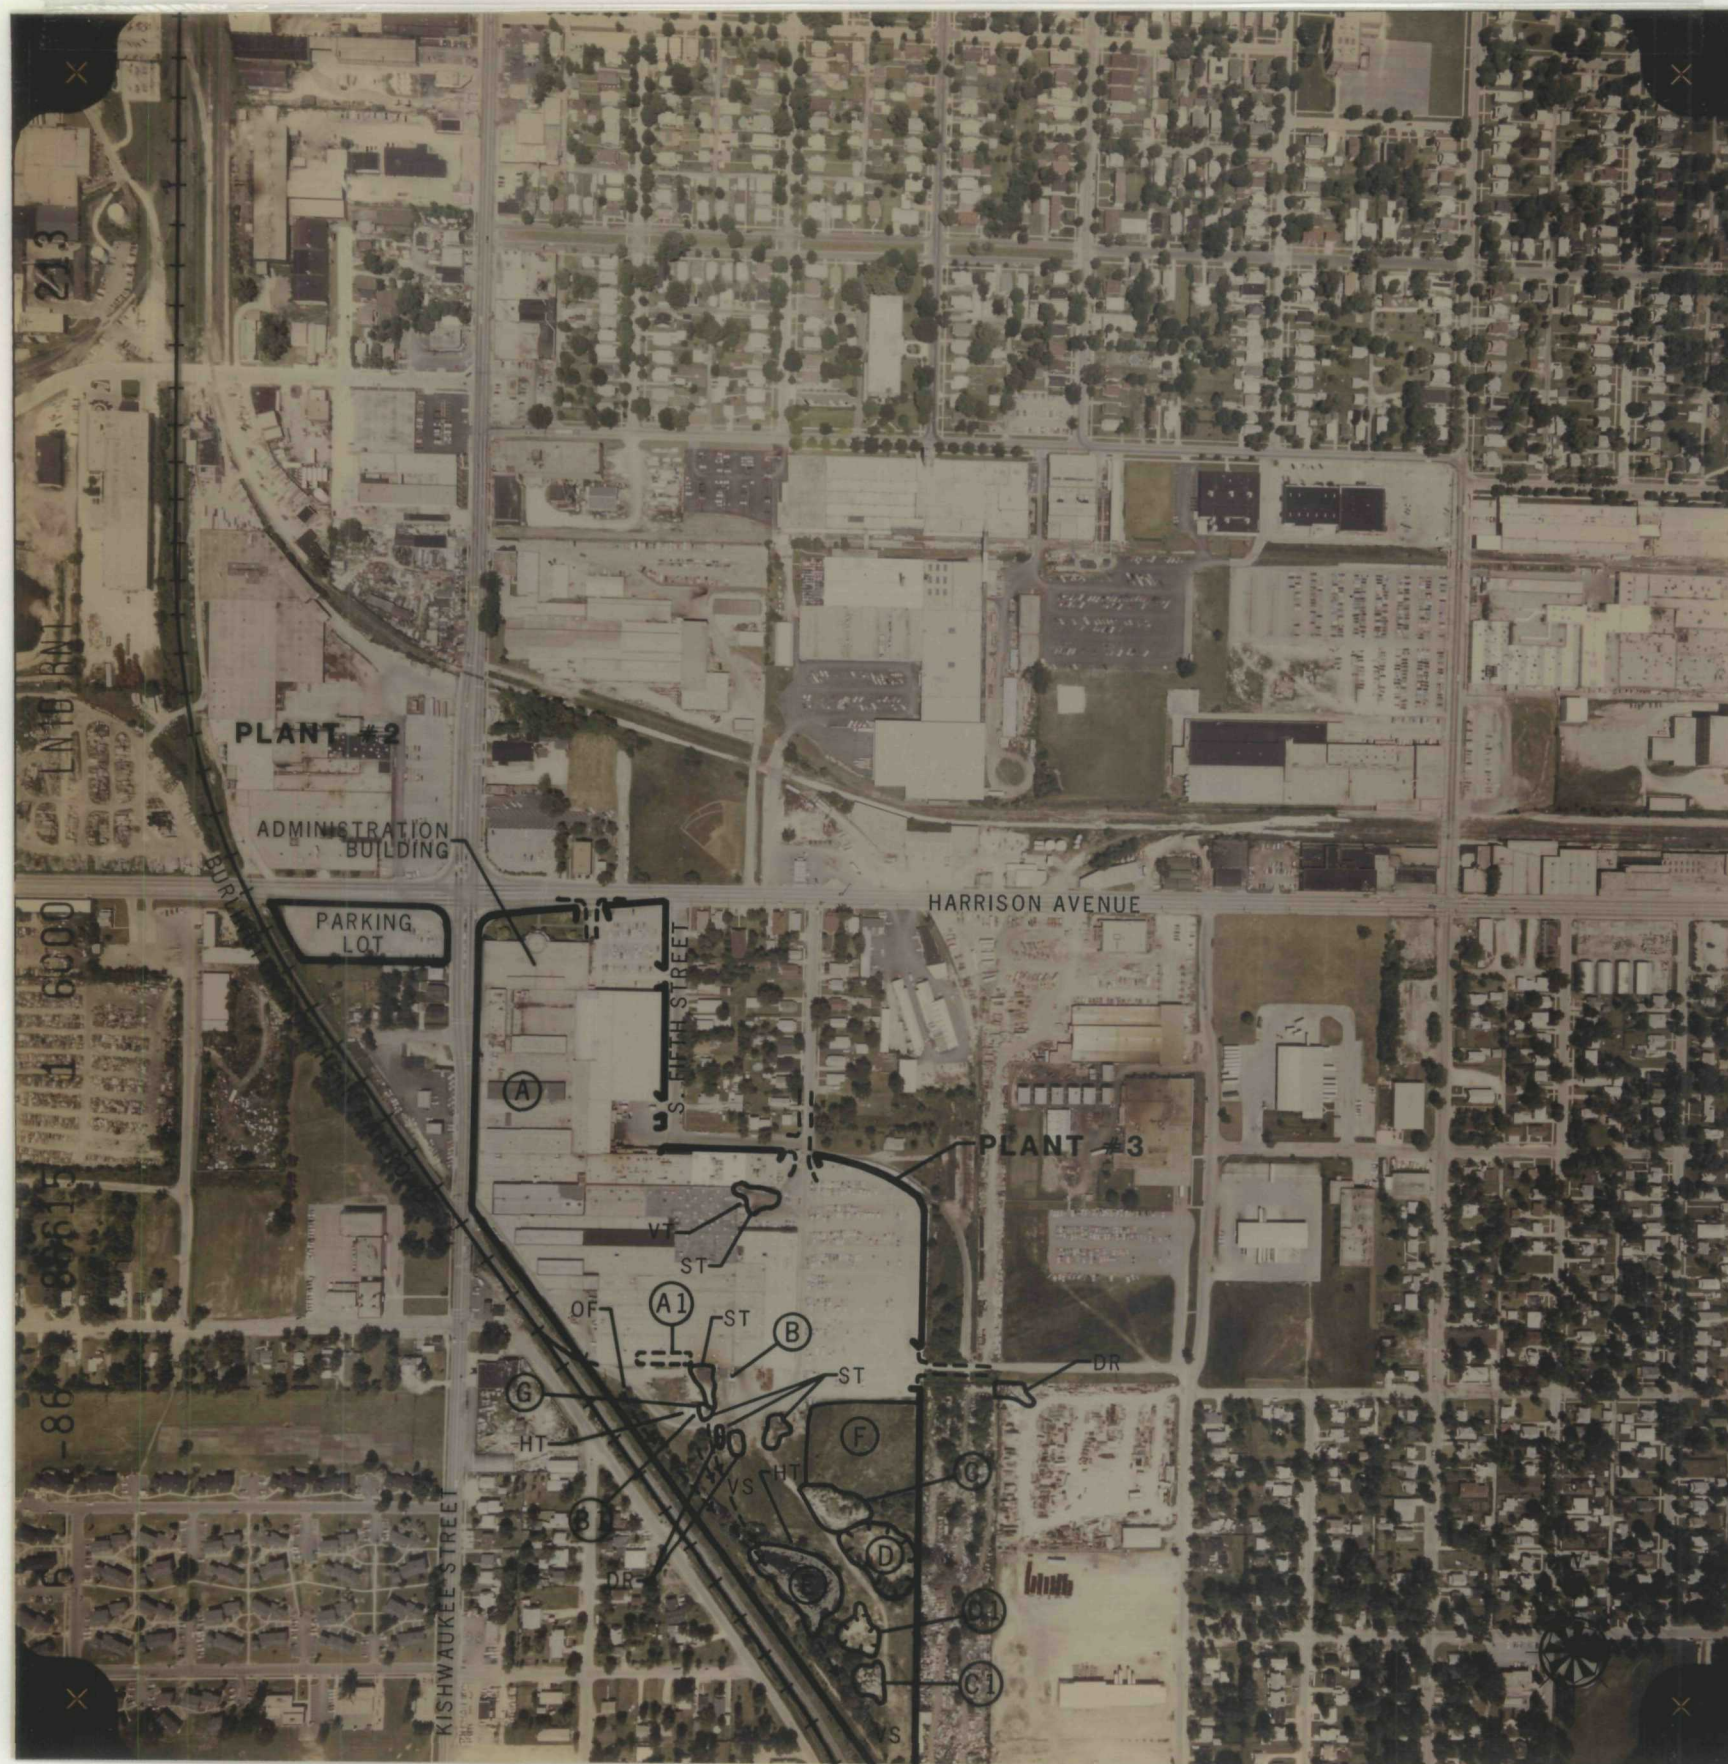
Figure 3. Rockford Products Corporation Plant #3, June 2, 1986. Approximate scale 1:6,000

This photo (Figure 3) shows the Rockford Corporation Plant #3 and Plant #2. No potential pollution sources are visible at Plant #2. Plant #3, the site under study, contains numerous pollution sources and potential pollution sources. The most significant features include:

<u>Annotation</u>	<u>Description</u>
A Waste Treatment Building*	This building is used to treat cyanide and chrome waste.
A-1 Incinerator*	Nothing significant is visible.
B Incinerator*	Nothing significant is visible.
B-1 Incinerator*	Nothing significant is visible.
C Surface Dump	This area contains solid waste and spoil.
C-1 Surface Dump	This area is mostly mounds of spoil. Solid waste is also visible.
D Excavation	The vegetation growth visible inside indicates the excavation is not new. A rusty drum is visible inside the excavation.
D-1 Excavation	This excavation appears to have had recent soil movement within, suggesting possible burial activity.
E Pond	This pond contains a dark-toned liquid and algae. The pond appears to have been formed by drainage from the site and local drainage network.
F Fill	This area appears to be a revegetated fill (possible landfill). The vegetation on this fill appears stressed.

G Leaking tank	This horizontal tank is leaking an oily liquid. The likely flow path would be south into the pond at Annotation E.

It appears that drainage from the site would flow south into an unnamed stream that empties into Rock Creek.
